LOUISIANA DEPARTMENT OF WILDLIFE & FISHERIES

WATERBODY MANAGEMENT PLAN SERIES

CADDO LAKE

**AQUATIC VEGETATION TYPE MAPS
AND NARRATIVES**

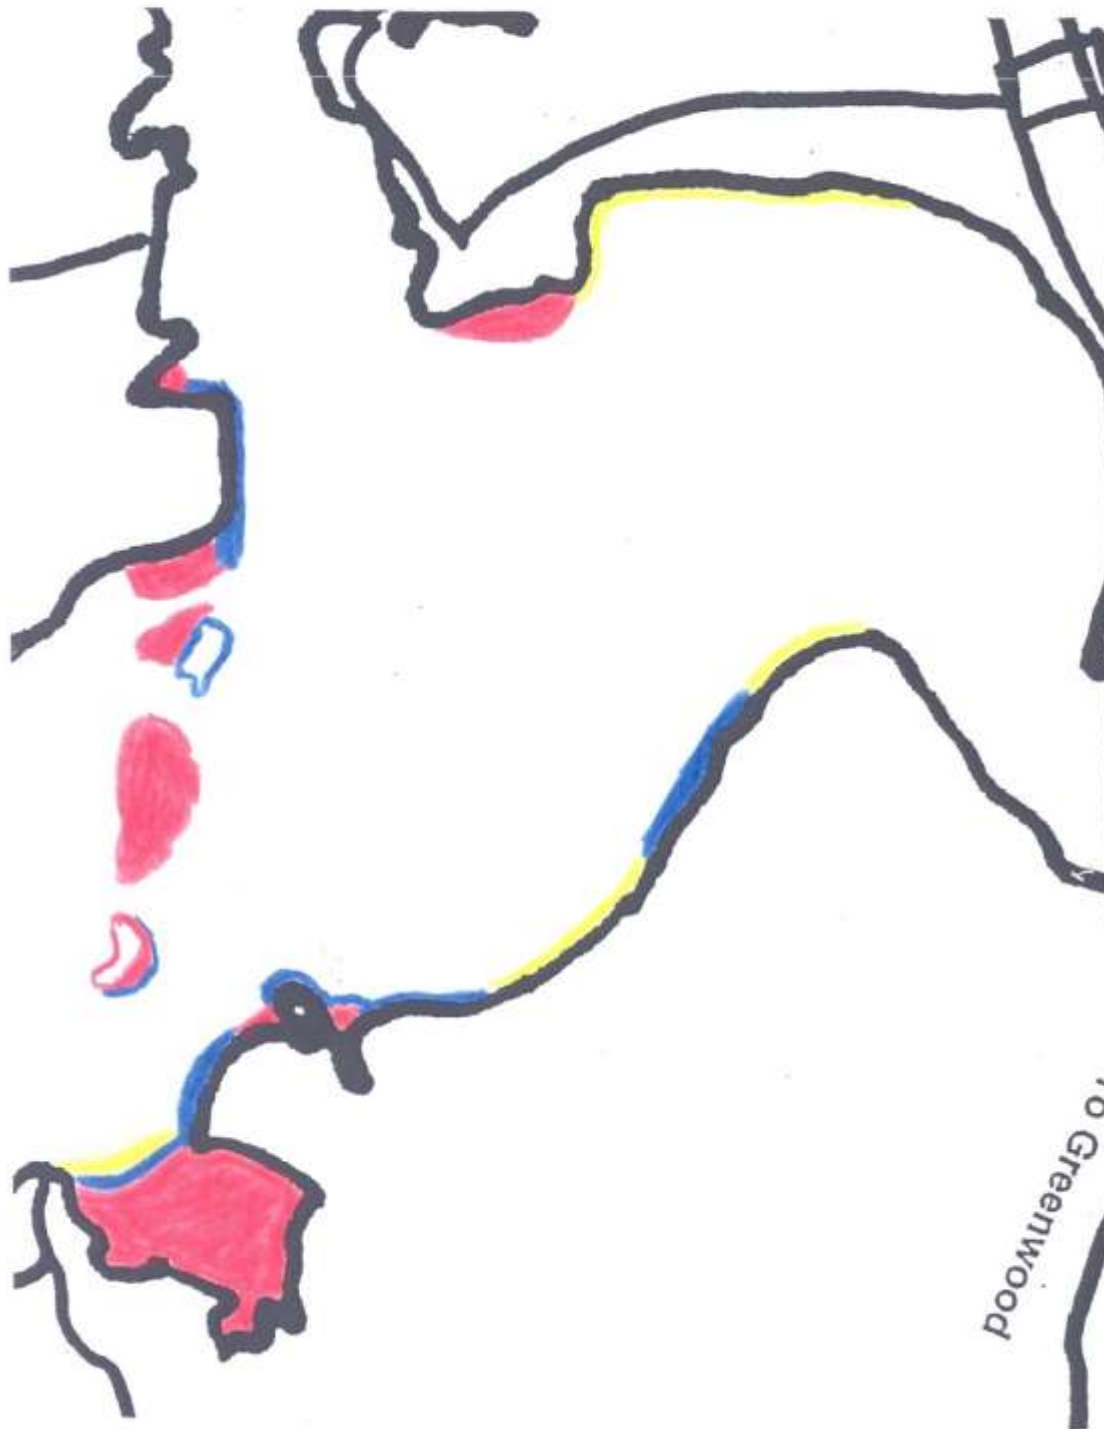
2006 Caddo Lake Type Map – Section B

CADDO LAKE 2006
SECTION B, MAIN LAKE

- Light Coverage
- Moderate Coverage
- Severe Coverage

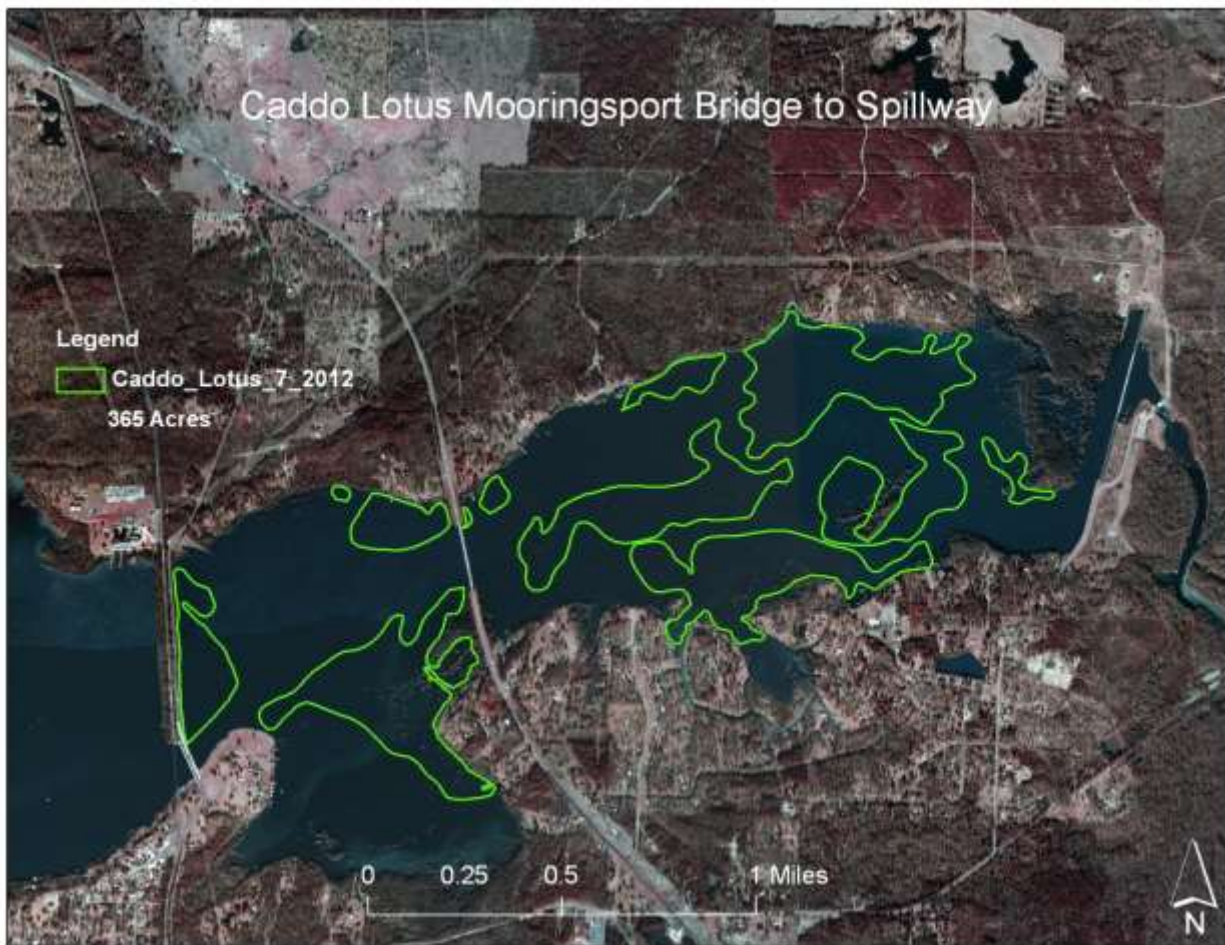
2012 Caddo Lake Type Map – American Lotus on Lower End of Lake
